**Draft Technical Memorandum**

**Orofino Asbestos Site**

**Vegetative Cover Performance Evaluation**

**April 14, 2014**

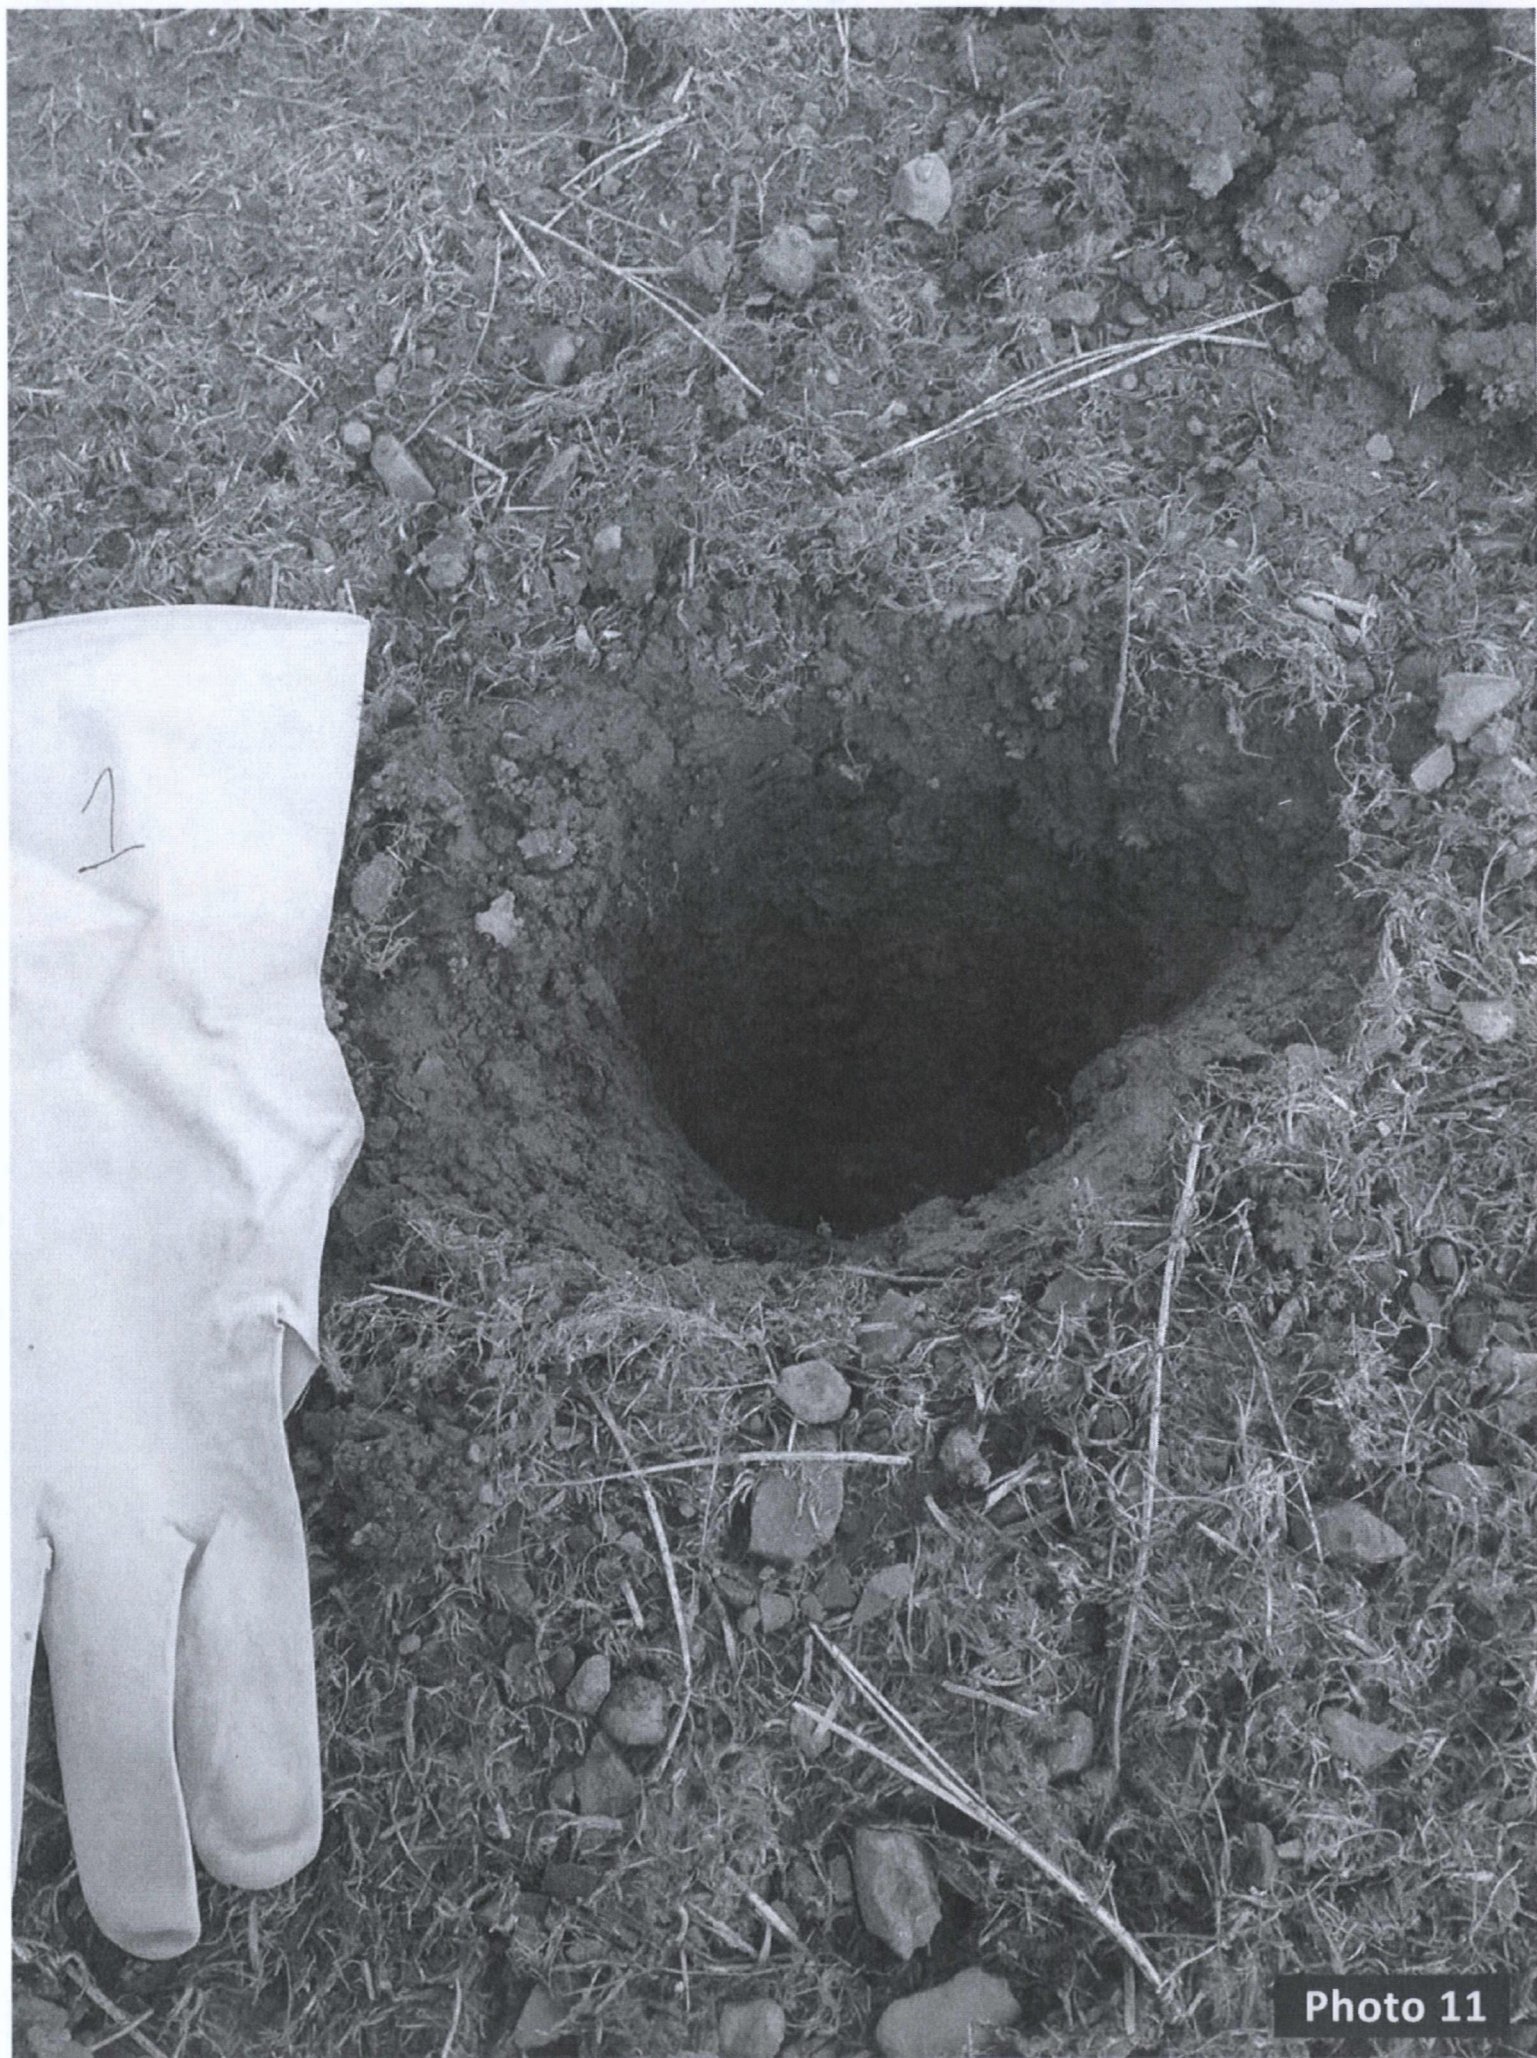
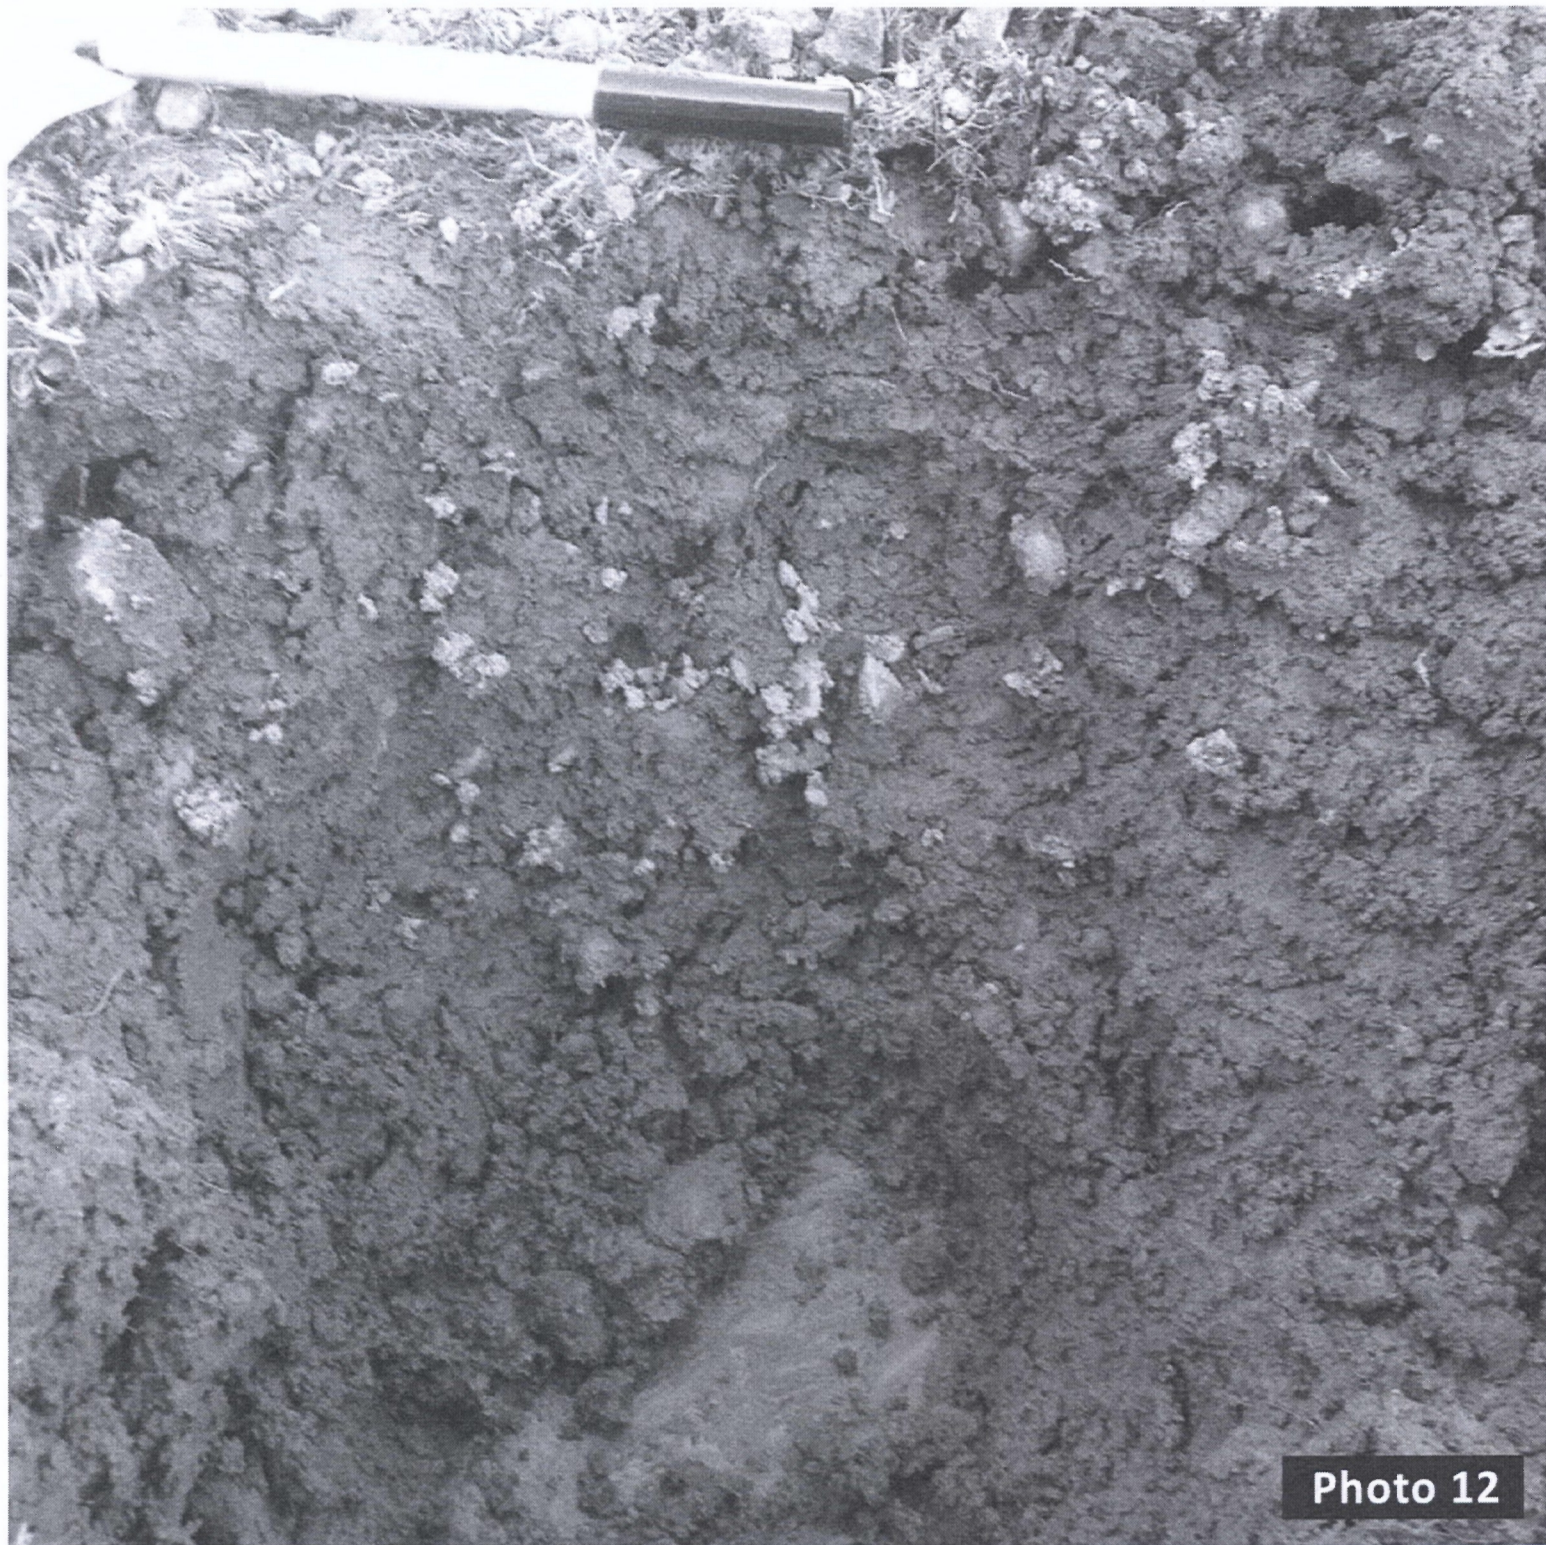
- 1) Gravel with silt/clay and sand, brown, saturated (grid points 1, 5, 6, 7, and 8). The amount of gravel ranged up to an estimated 50 percent. The gravel is angular and ranges up to 1.5 inches across. Due to the saturated conditions, the ability to perform field estimation of the grain size distribution (i.e., soil texture by feel method) was very limited. The distribution of grain sizes of the sand was difficult to assess in the field because of the large proportion of fines, both visually and by feel. See Photos 11, 12, and 13.
